Manhole Inspection Summary

Manhole # S33CC2005MH

Insp Date: **12/19/06 3:21 PM**

Location Address: **208 CHURCHWARDENS RD** Cross Street: **NORTHERN PKWY**

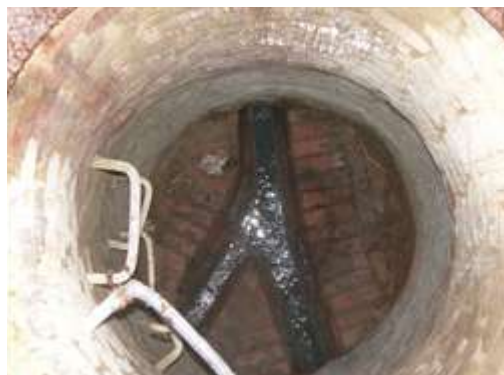
Top View

Bench debris.

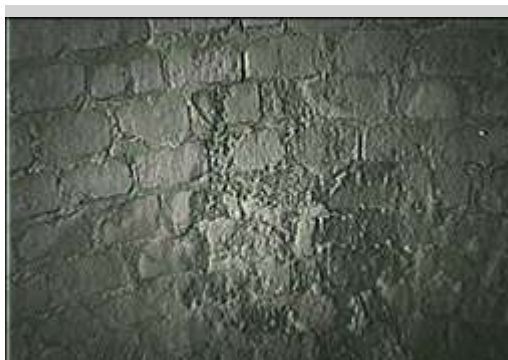
Defect

Barrel deterioration and infiltration.

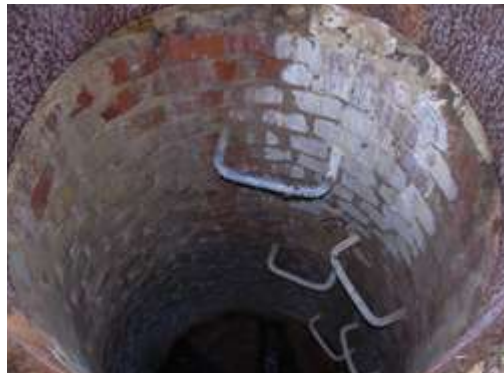
Defect

Adjustment deterioration and infiltration.
Corbel and Barrel infiltration - other side.

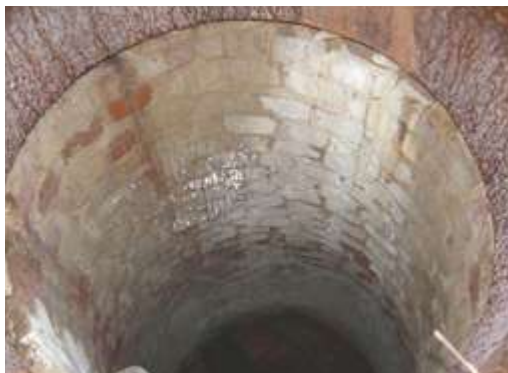
Defect

Adjustment, Corbel and Barrel infiltration.

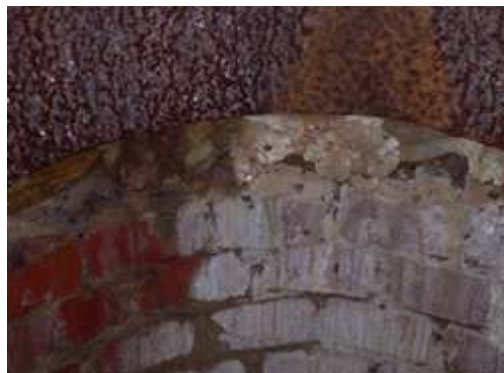
Defect

Adjustment deterioration and infiltration.

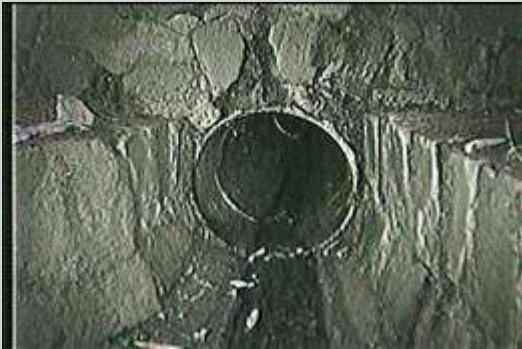
8 in. Circular Gravity Sewer Pipe Out @ 12 O'Clock

Infiltration: **None** Pipe Seal Cond: **Cracked**

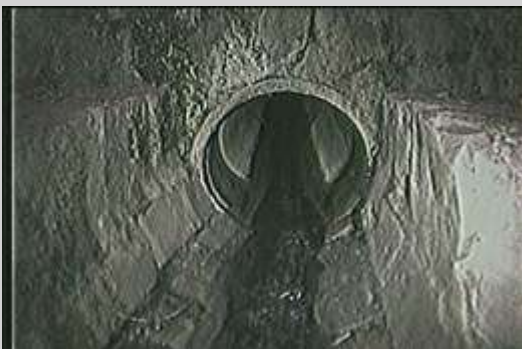
8 in. Circular Gravity Sewer Pipe In @ 5 O'Clock

Channel deterioration.

Infiltration: **Evidence** Pipe Seal Cond: **Cracked**

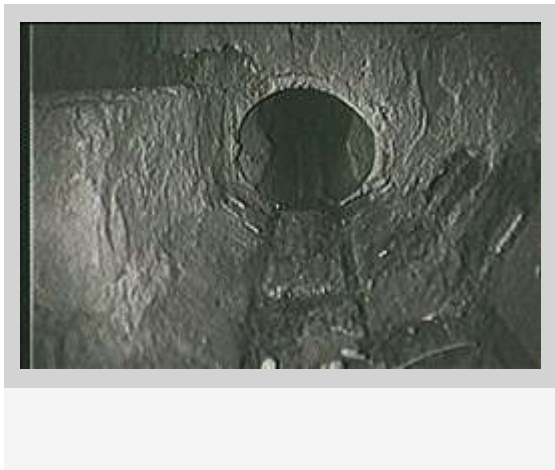
6 in. Circular Gravity Sewer
Pipe In @ 7 O'Clock

Infiltration: **None** Pipe Seal Cond: **Cracked**
